# Recent Catastrophic Failures of Boiler Components – Where do we go from here?

Presented by  
George W Galanes, P.E.  
Metallurgical Consulting Engineer  
DTS Inc

# Primary Superheater Link Pipe Ruptures

# Failure #2

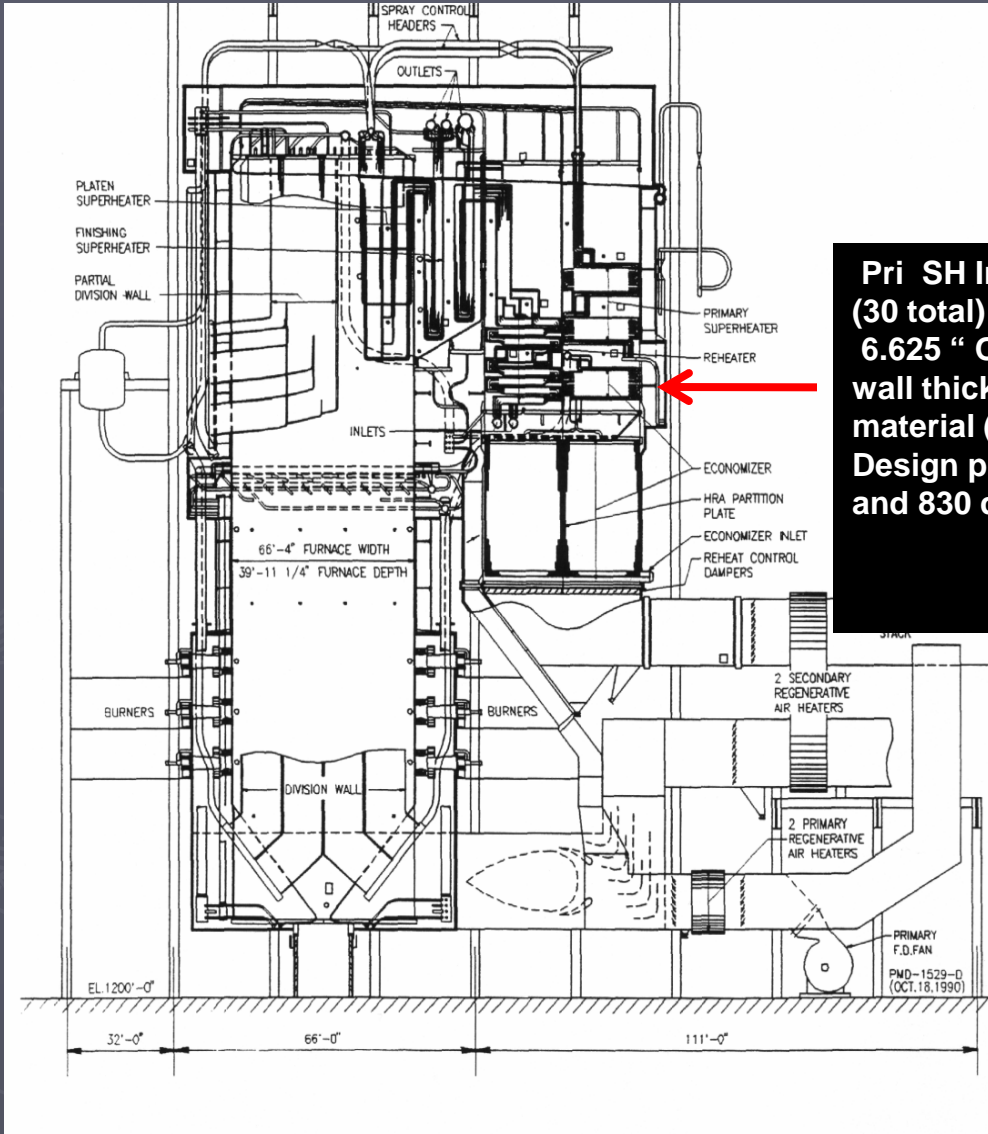
# Typical Boiler Layout

**Pri SH Inlet Feeder Pipes**  
(30 total) (136 sweeps)  
6.625 " O.D. x 0.935 " minimum  
wall thickness of SA335 P1  
material (carbon - moly steel).  
Design pressure is 4,180 psig  
and 830 deg. F.

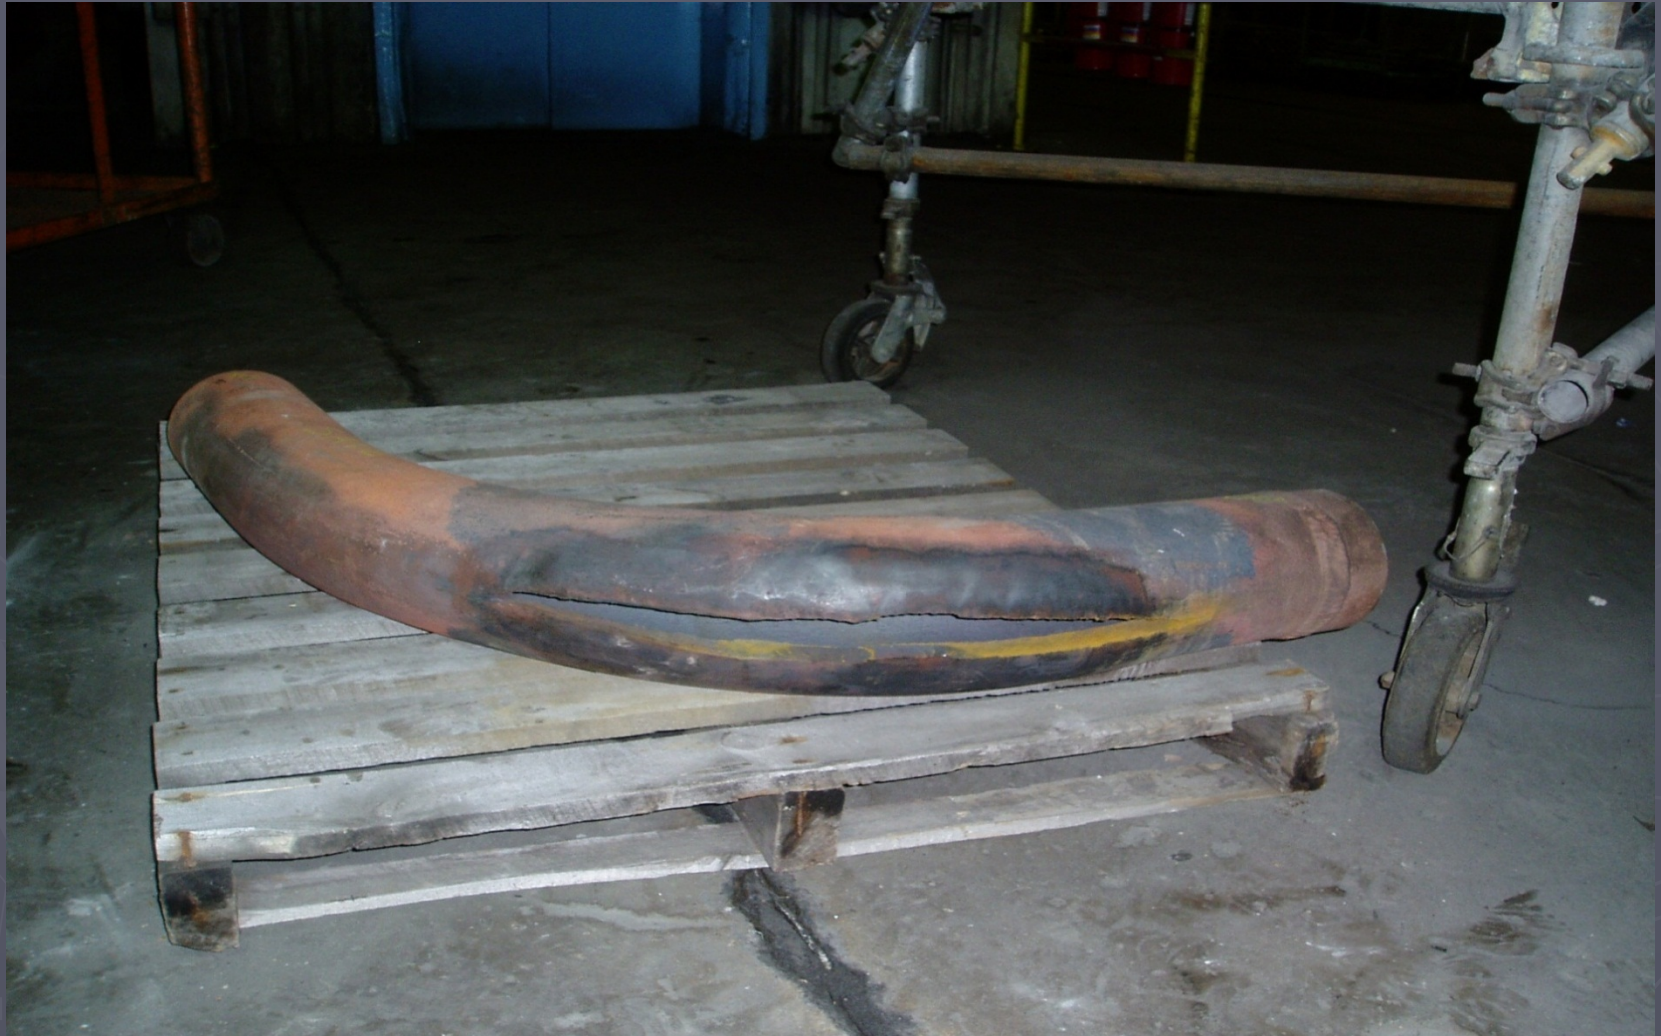
# Type of Rupture

- ▶ Thursday 2/10/11, Primary Superheater inlet pipe ruptured @ 7:37 a.m. (during normal AM load increase (5 mw/min) at 606 mwg)

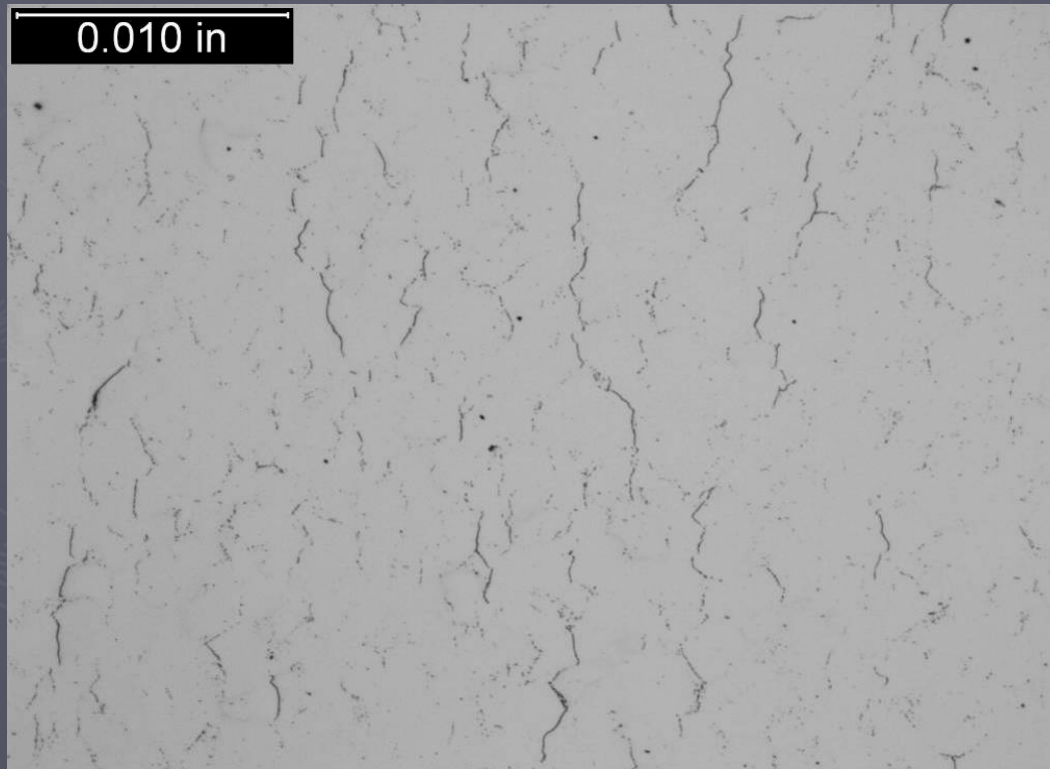
# Look Closely

It was determined that the cause of failure in the primary superheater (PSH) inlet sweep was a damage mechanism confirmed to be grain boundary graphitization.

- ▶ This type of damage mechanism is time dependent, meaning as the Grade P1 remained in elevated temperature service, the pipe would exhibit continued significant loss in toughness and ultimately fail catastrophically (no leak before break) in service.
- ▶ The failure initiated and propagated from the OD surface of the bend extrados. This location would have been exposed to the highest forming strains. Bulk hardness testing confirmed the extrados as having the highest hardness( approximately 200 HV in comparison to straight sections at 165 HV).
- ▶ Loss of toughness and significantly reduced elongation values were confirmed in the formed sweeps versus straight sections of Grade P1 piping based on extensive mechanical property testing.

- ▶ Grain boundary graphitization was confined to formed bends did not appear to have been thermally treated after forming.
- ▶ Because the grain boundary graphitization damage mechanism is not well understood or reported in literature it was more difficult to quantify severity of damage in comparison to the more traditional form of graphitization damage (graphite nodules).
- ▶ Fortunately, after extensive sampling of sweeps and straight pipe sections of known Grade P1 PSH pipe material, there was no grain boundary graphitization observed in straight sections of Grade P1 pipe because these pipe spools contained no residual forming strains.

- ▶ Based on the findings from the Unit PSH sweeps, a review was performed to determine the extent of Grade P1 pipe material installed in this boiler and in a second boiler (sister unit).
- ▶ Carbon steel piping was also sampled as a precaution. No grain boundary graphitization damage was detected for carbon steel piping.
- ▶ In addition, a search of Grade P1 material was expanded to include the remaining coal-fired units for this client. No other Grade P1 piping was installed in the boiler proper.
- ▶ After careful review of metallurgical test results for sampled Grade P1 pipe material locations in both boilers, it was recommended to replace the original Grade P1 sweeps with SA 335 Grade P22 material and monitor the remaining P1 piping until full replacement using SA 335 Grade P22.

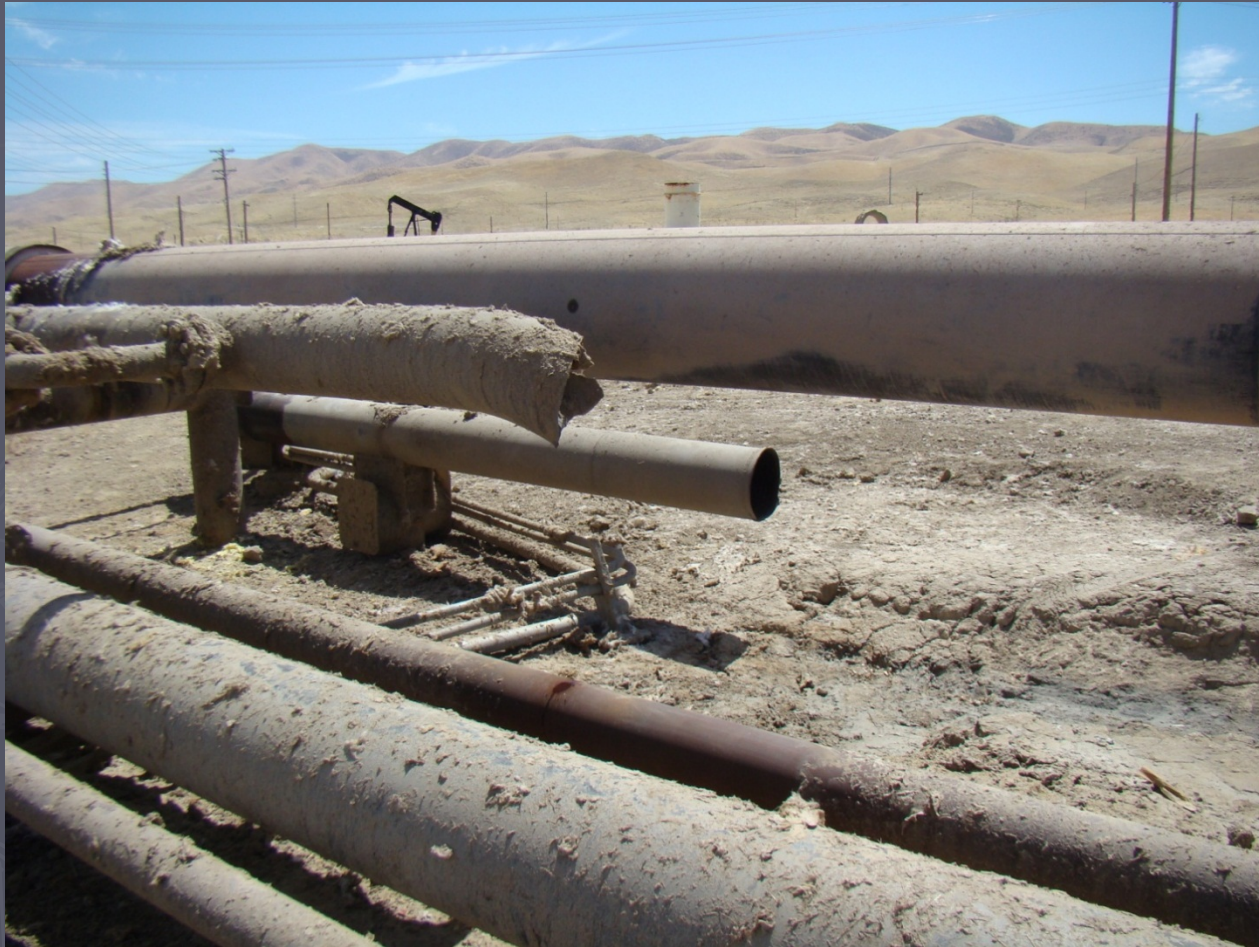
# Failed Warm-up Line

- ▶ Failure of the warm-up line  
internal wastage that weakened the pipe resulting in catastrophic rupture in service at multiple locations within the line.
- ▶ The internal wastage  
corrosion from either stagnant or pooled condensate during off-line conditions from exposure to air atmosphere. There was no evidence of internal erosion or erosion/corrosion that contributed to the failure.

- ▶ Develop inspection plans for the warm-up line and other high energy steam lines. The inspection program results should be reviewed independently of site personnel to ensure no gaps or missed opportunities for corrective actions.
- ▶ Survey the replacement warm-up line and other lines that are used on an infrequent basis to determine the need for drains or drain pots to avoid having similar internal corrosion problems.

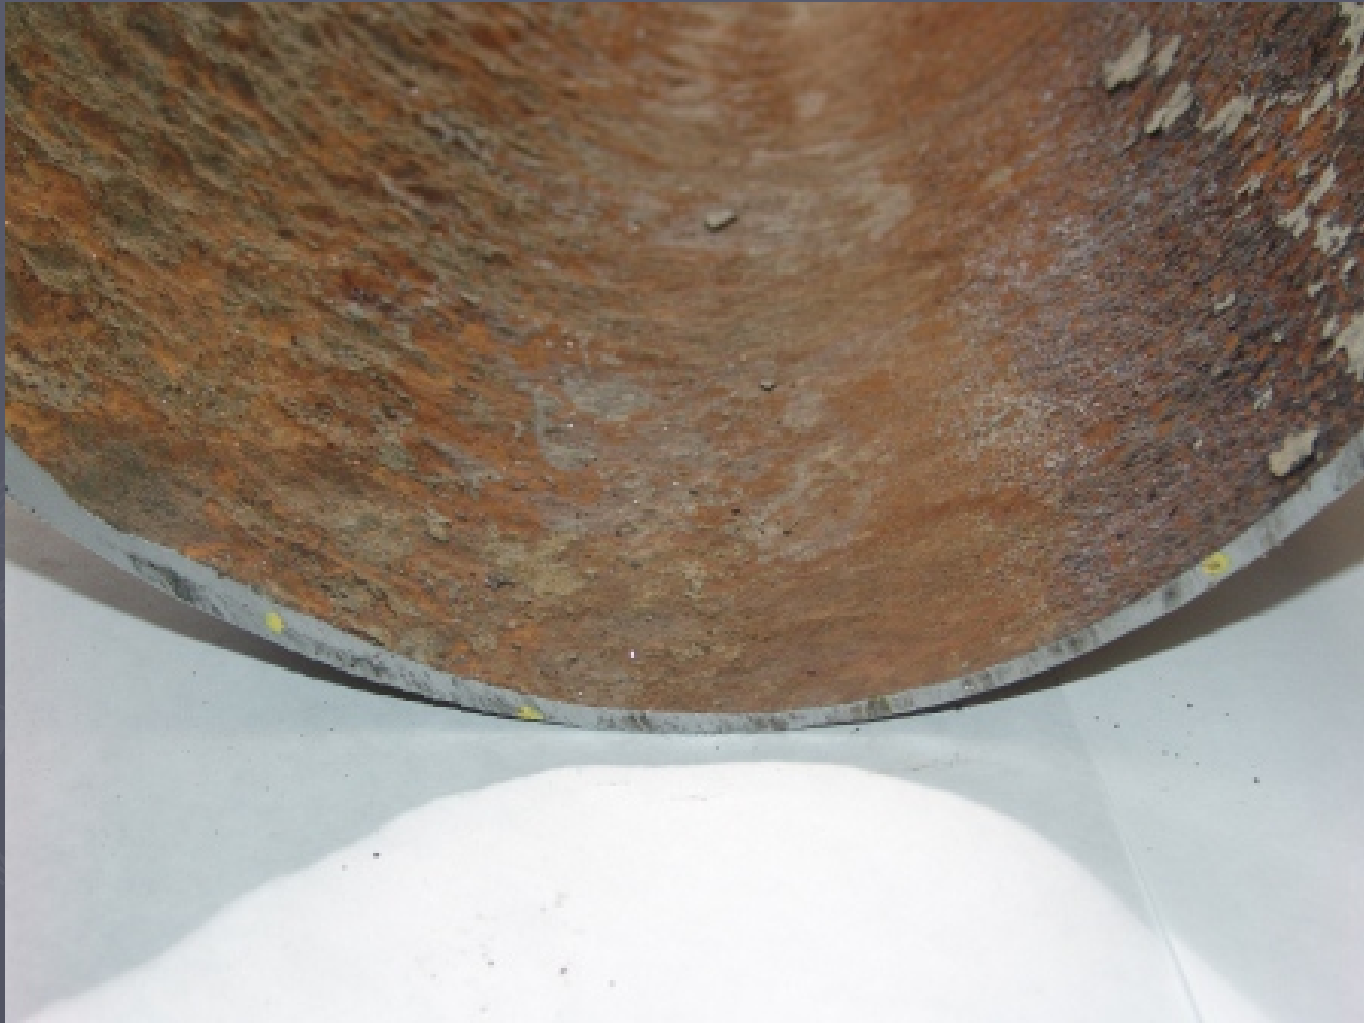
# Local thinning from corrosion
